Manhole Inspection Summary

Manhole # S33I__043MH

Insp Date: **3/26/08 8:25 AM**

Location Address: **side of 200 w. pratt**

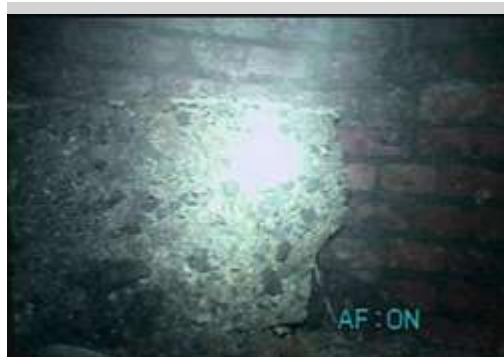
Defect 4

Condition: ☐ Sound ☐ Cracked ☐ Root Intrusion ☐ Deteriorated ☐ Leaks ☒ **Debris**

bench debris

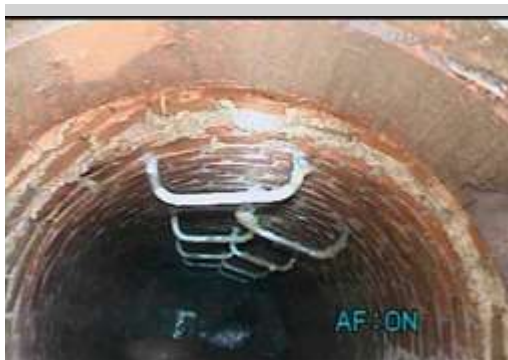
Defect 3

Steps Count: **9** Missing: **0** ☒ **Corroded**

steps

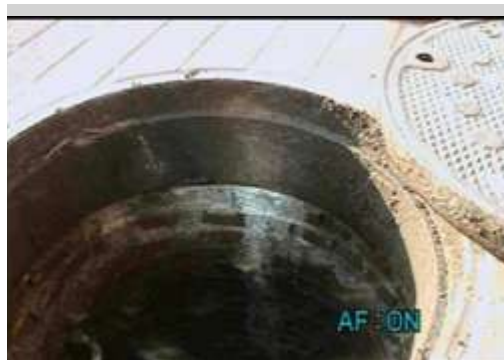
Defect 2

Condition: ☐ Sound ☐ Cracked ☐ Root Intrusion ☐ Loose Brick ☒ **Deteriorated**

Infiltration: ☐ None ☐ Joint ☐ Cracks ☐ Mortar ☐ Roots ☒ **Wall**

chimney deteriorated with infiltration from wall

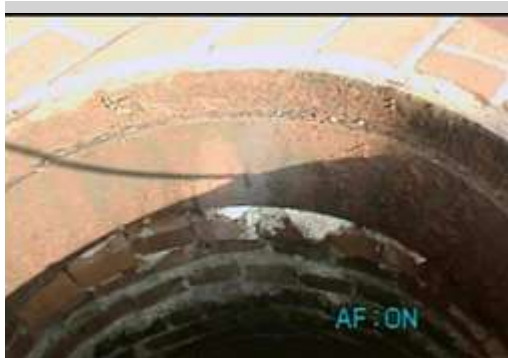
Defect 1

Frame Offset: **1** (in.) Condition: ☒ Sound ☐ Cracked ☐ Leaks

offset

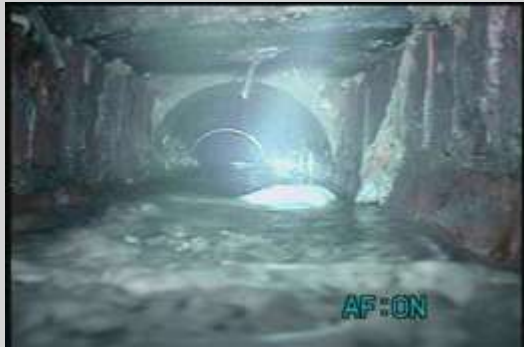
12 O'Clock Outflow

Deposits: ☐ None ☐ Mud ☐ Sludge ☒ **Debris** ☐ Grease

Silt Depth: 0 (in.) Deposits Extent: **Light**

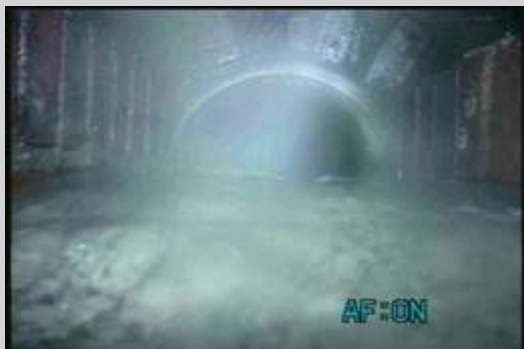
6 O'Clock Inflow

Deposits: ☐ None ☐ Mud ☐ Sludge ☒ **Debris** ☐ Grease

Silt Depth: 0 (in.) Deposits Extent: **Light**
